Silicon Errata for the MSC8101 Processor, Mask 0K40A

This document presents the errata for the 0K40A mask of the Freescale MSC8101 device. The errata are classified and numbered, and each erratum is provided with a description and workarounds. **Table 1** lists the mask numbers and the corresponding versions of the MSC8101 device.

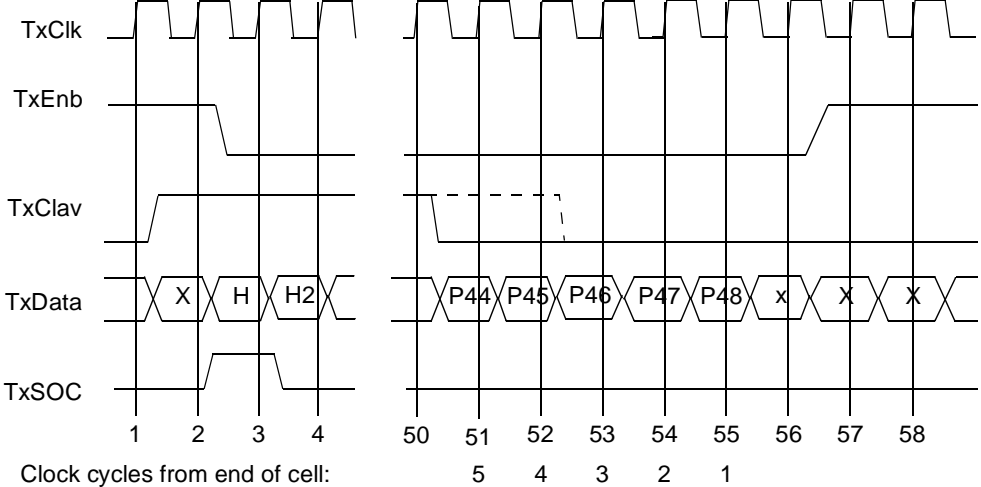
Errata Number	Errata Description	Applies to Mask
<p>CPM101</p>	<p align="center">FCC RxClav Timing Violation (Slave)</p> <p>Date Added: 1/15/2004 Date Revised: 11/05/2004</p> <p>Description: FCC ATM Receive UTOPIA slave mode. When the RxFIFO is full, RxClav is negated 2 cycles before the end of the cell transfer, instead of 4. A master that polls RxClav or pauses 3 or 4 cycles before the end of the cell transfer may sample a false RxClav, and an overrun condition may occur. The dashed line in the timing diagram below depicts the actual RxClav negation (two cycles before the end of the cell transfer instead of four cycles). The signals in the timing diagram are with respect to the master, so the Tx interface is shown.</p> <p>Workaround:</p> <ol style="list-style-type: none"> The master should not poll RxClav or pause a cell transfer 4 cycles before the end of a cell transfer. The master should poll 2 cycles before the end of the current cell or later. This can be achieved by introducing cell-to-cell polling (and transfer) delay, which is equal or larger than one cell transfer time. If this can be achieved, the impact on performance is minimal. Configuring ATM only on FCC1 and setting FPSMR[TPRI] ensures the highest priority to FCC1 Rx. In addition, for CPM usage lower than 80 percent (as reported by the CPM performance tool based on UTOPIA maximal bus rate), the CPM performance is enough to guarantee that the RxFIFO does not fill up.

<p>Clock cycles from end of cell: 1 2 3 4 50 51 52 53 54 55 56 57 58 5 4 3 2 1</p>	<p>0K40A</p>
