# ES\_LPC3230

Errata sheet LPC3230

Rev. 9 — 1 June 2011

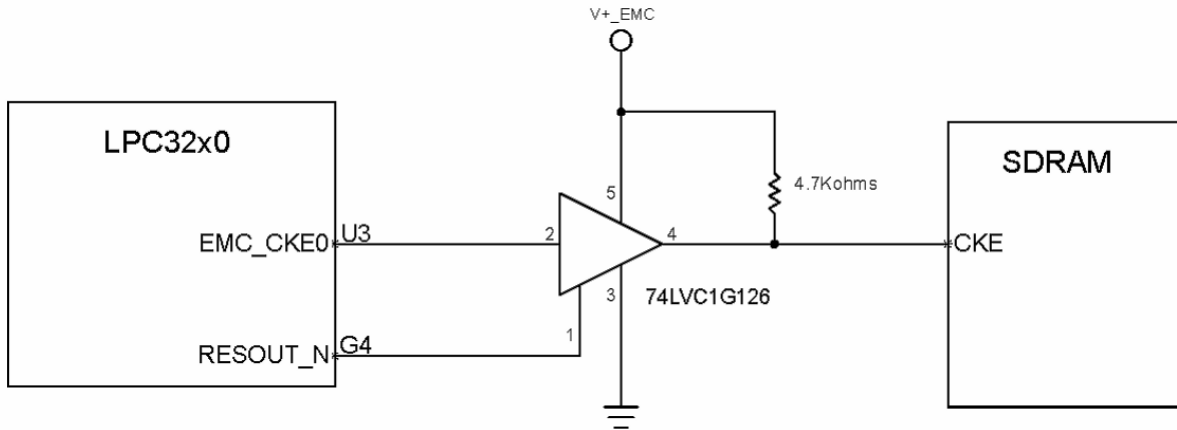
Fig 3. 128 MB DDR SDRAM example

If the LPC3230 is reset during an SDRAM access, the SDRAM clock and clock enable will be immediately de-asserted. If the de-assertion occurs during the period of time the SDRAM is driving the data bus, the SDRAM will hold that state until the next clock occurs at the SDRAM clock input when the clock enable is active. However, the LPC3230 won't deliver the clock and clock enables until software actually sets up the EMC state to do this, so the SDRAM will remain in the data assertion state on the data bus while the LPC3230 tries to boot.

When the chip attempts to load boot code from NOR FLASH after reset, the correct signals are asserted to the NOR FLASH device and the NOR FLASH device places its data on the data bus. But if the SDRAM is still driving the bus, the NOR FLASH device and SDRAM device are in contention and the data will not be read correctly into the LPC3230. In this situation, the LPC3230 will fail to boot.

If booting from NOR FLASH is a requirement, the simple circuit shown in [Figure 3](#) can be used to clear the SDRAM state at system reset. This will not change the normal functioning of the LPC3230 EMC or SDRAM operations. If SDRAM devices are also present on the 2nd SDRAM chip select, a similar circuit will be needed for those devices using EMC\_CKE1.

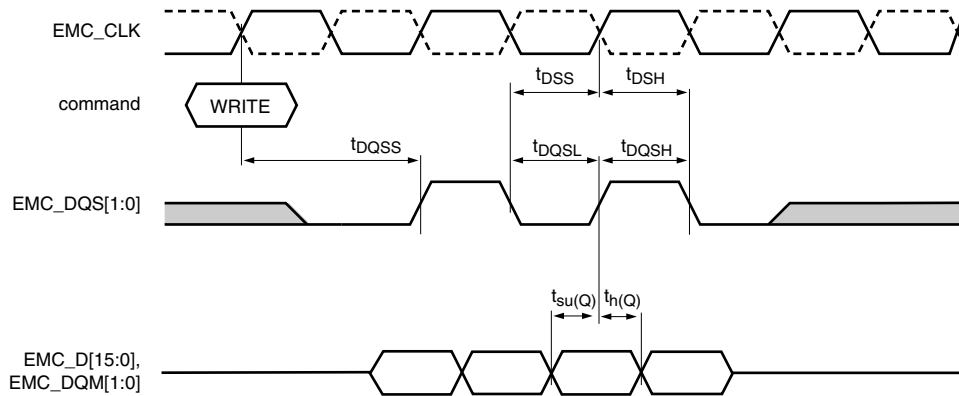
Fig 4. Basic DDR write timing

For DDR writes the LPC3230 drives the EMC\_DQS[1:0] earlier in the data valid window than center aligned. With the EMC\_CLK at 133 MHz this produces a minimum set-up time between the EMC\_D[15:0] and EMC\_DQS[1:0] of 600 ps across silicon process, voltage and temperature. Test conditions are with the EMC buffers set to fast slew rate driving

2 inches of 50  $\Omega$  transmission line and 10 pF load capacitance. DDR memories specify EMC\_D[15:0] to EMC\_DQS[1:0] set-up time minimum as 400 ps. This leaves 200 ps set-up time margin due to customer specific load and PCB layout implementation. See the LPC3220\_30\_40\_50 data sheet for the complete range of DDR data output set-up time,  $t_{su(Q)}$ , and data output hold time  $t_{h(Q)}$  times.
