# **Cortina Systems® LXT973 10/100 Mbps Dual-Port Fast Ethernet PHY Transceiver**

## **Specification Update**

**20 March 2007**

**Revision 10.0**

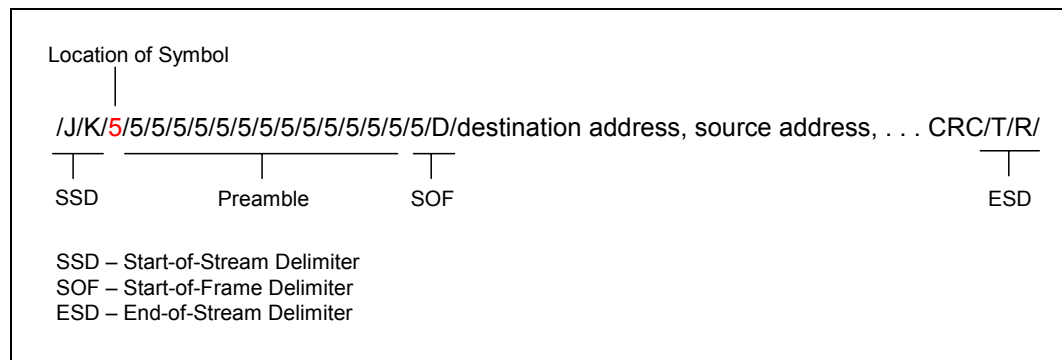
**Problem** An illegal symbol placed immediately after the Start-of-Stream Delimiter (SSD) (preamble after JK) is not detected. However, any subsequent corrupt symbol will be detected.

**Implication** RXER will not assert if this symbol location is corrupted. However, an error in this location does not affect packet integrity.

**Workaround** Use the MAC layer protocol to detect corrupt symbols in the packet.
