## ENVIRONMENTAL REPORT: EXECUTIVE SUMMARY

## ENVIRONMENTAL / HALT TEST REPORT

**FAMILY:** GPMP / GPHP  
**MODEL:** GPMP600-24  
**REVISION:** A

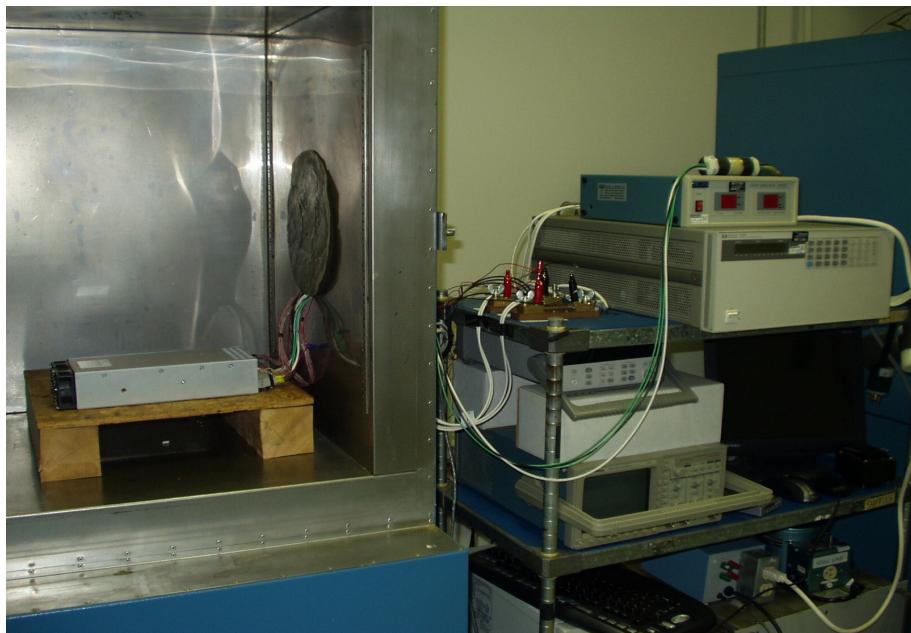
Typical thermal survey and HALT setup.

Ransco 1310 Temperature Chamber (24"x24"x30")  
HP 34970A 60 Channel Data Acquisition System  
Ling Electronics DMA-5/390-3 3000 lb<sub>f</sub> Electrodynamic Shaker  
Kimbol 24"x24" Oil Film Slip Table  
24" Head Expander  
Data Physics Corporation SignalCalc 350 Vibration Controller  
Dytran Model 3100B Accelerometer/4114B Power Supply (Control)
