**PM5362**

**TUPP-PLUS**

**SONET/SDH TRIBUTARY UNIT PAYLOAD PROCESSOR /  
PERFORMANCE MONITOR**

**DATA SHEET ERRATA**

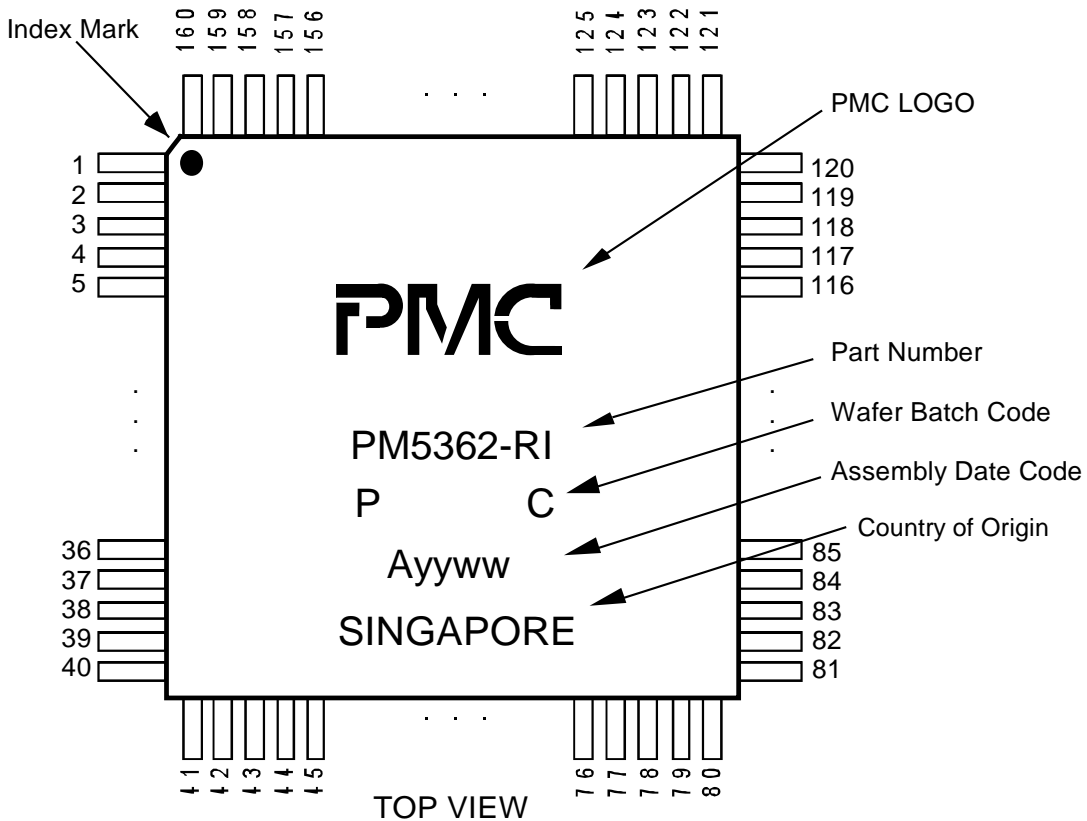
TOP VIEW

The information in this document applies only to the PM5362 TUPP-PLUS Revision C device. The device revision is marked at the end of the wafer batch code on the face of the device.

SCALE : 3:1  
(APPROX.)
