# ***82546GB Gigabit Ethernet Controller Specification Update***

***June 6, 2006***

The 82546GB Gigabit Ethernet Controller may contain design defects or errors known as errata that may cause the product to deviate from published specifications. Current characterized errata are documented in this Specification Update.

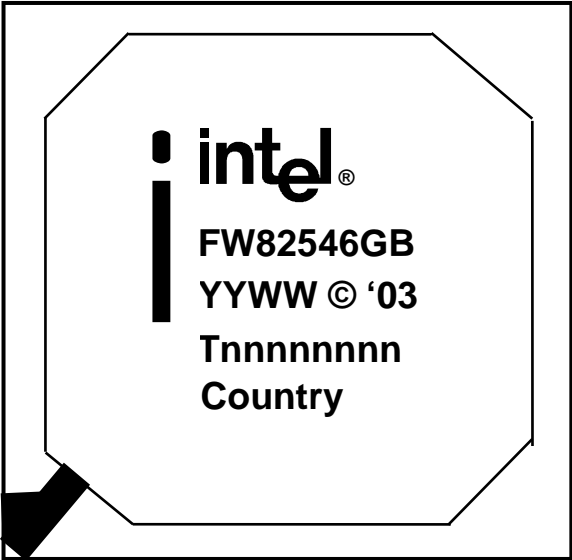
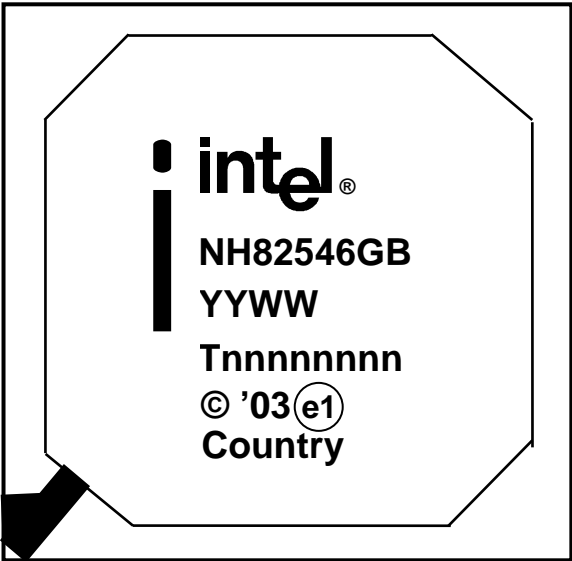
Lead-Free Component Marking

Product	Stepping	QDF Number	Top Marking	Notes
82546GB	A0	Q783	FW82546GB	Engineering Samples
82546GB	A0	Q541	NH82546GB	Engineering Samples (Lead-Free)
2546GB	A0	-	FW82546GB	Production
82546GB	A0	-	NH82546GB	Production (Lead-Free)
