PM8315

TEMUX

**High Density T1/E1 Framer with
Integrated VT/TU Mapper and M13 Mux**

**Errata
for the Production Released Device**

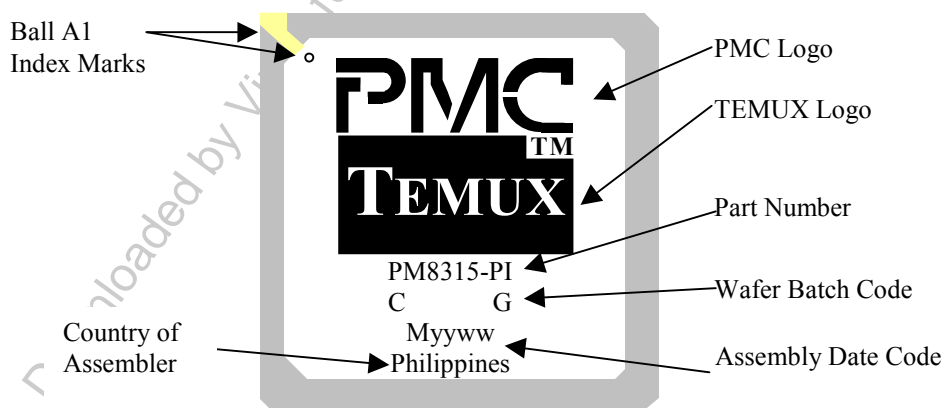
Figure 1 PM8315 Branding Diagram

The prototype TEMUX devices are denoted with a –P following the part number that is labeled on the device (ie. PM8315-PI-P signifies a prototype while PM8315-PI signifies a production part). The errata for the prototype TEMUX devices is contained in the PM8315 TEMUX Datasheet Errata (PMC-1990677, R9) available from your local sales representative.
